# STVision

## Wire Bond Inspection System For Thick Wire AI Bonds Nov 2005 STVision

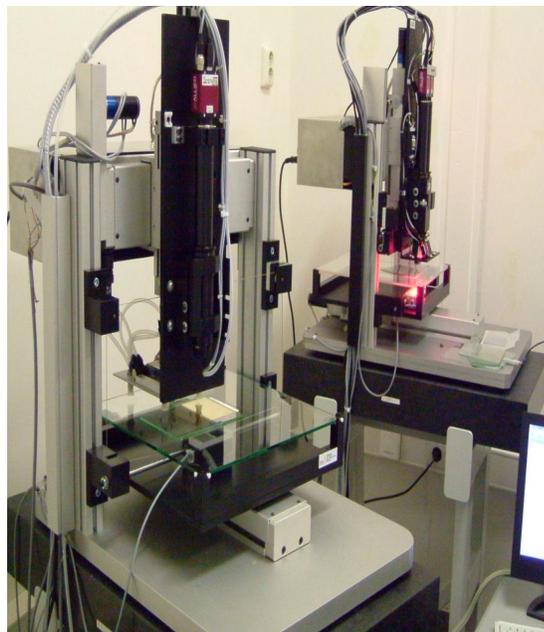
- Position of the leadframe,
- Position of the die,
- Inspection of the die surface,
- Detection of solder / epoxy splash,
- Die chips, cracks, scratches,
- Measures the bond location,
- Measures the wedge width and tail,
- Broken wires,
- Wire sweep,
- Bad bond scheme,
- Measures the loop height in direct side view,
- Lifted bonds,
- Partially lifted bonds,
- Double bonds,
- Epoxy wetout.
- Up to 6 cameras for inline operation

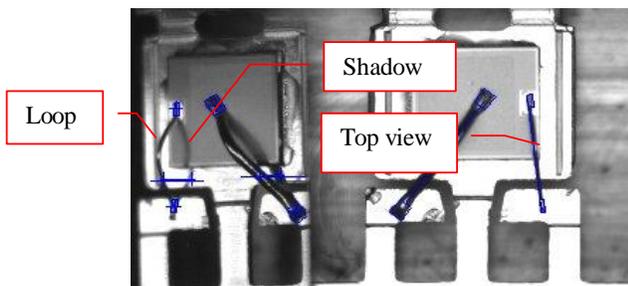
In subsequent image you have an example of the shadow evaluation (red marks). Shadow and loop are measured at specific user defined points. Tolerances can be set for minimum and max loop heights.

Three views to the device (top and two side views) are combined into a single camera image. The wire loop and wedge profile are directly visible in the side view. The spacing between shadow cast and wire directly correlates to the loop height. The system evaluates the XY loop profile first, and then utilizes the side views for height calculation.

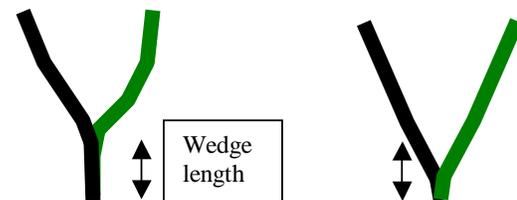
See the difference between good bond (left) and partially lifted one (right):

Specifically the partially lifted bond may not even be discovered during pull testing.
